*Engineering for Polar Operations, Logistics, and Research (EPOLAR)*

## **Waste Water Handling Proof of Concepts at McMurdo Station, Antarctica**

September 2014

Final Report

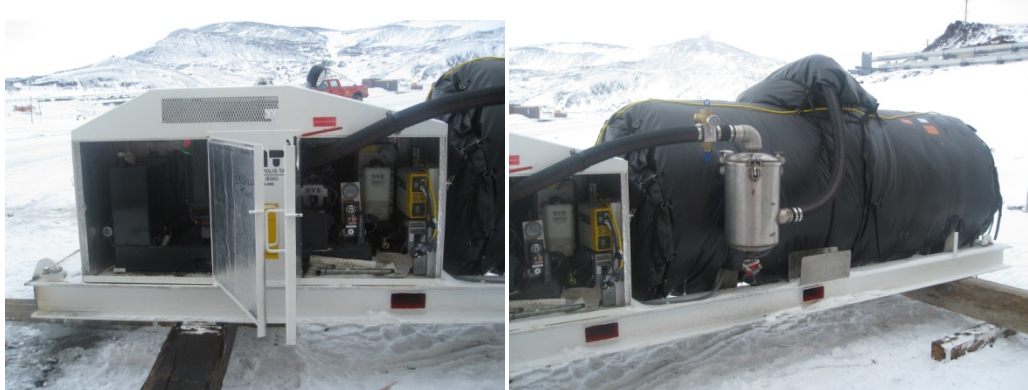
Figure 1. Vacuum tank as it arrived from manufacturer.

Brown-Minneapolis Tank designed and manufactured the vac tank to transfer waste from Pegasus to the WWTP (Figure 1). As mentioned previously, the vac-tank system was designed to pump wastewater from holding tanks at Pegasus into the 1000 gal. portable transfer tank. The vac-tank package selected by RPSC included an on board engine (fueled by AN-8) that drove the pump to transfer the waste from the holding tanks at Pegasus to the tank. This same pump was used to empty the tank at the WWTP. This tank included a leak protection layer to reduce the possibility of spill-

ing effluent during transfer or transit. The entire vac-tank system was mounted on two I-beams with fork pockets to allow easy installation and removal of the system from a Delta or trailer bed when not in use. Heat trace and a thermal blanket covered the exterior of the tank to prevent freezing of the waste during transit. The vac tank was competitively bid, and the contract was awarded to Brown-Minneapolis Tank. The anticipated maintenance was expected to be minimal. RPSC and CRREL determined that, in an effort to reduce potential maintenance and vehicle down time, the POC should be removable from the prime mover that it was attached to. If this form of waste management was to be implemented full time, a dedicated prime mover would be the viable option. The recommendations section of this report provides more details on this.

As delivered, there was no onboard capability to power the heat trace, and insufficient capacity was available on the Delta that was used during the 2011–12 season. During the 2012–13 season, Lockheed Martin added a generator to the package to power the heating system during transport.

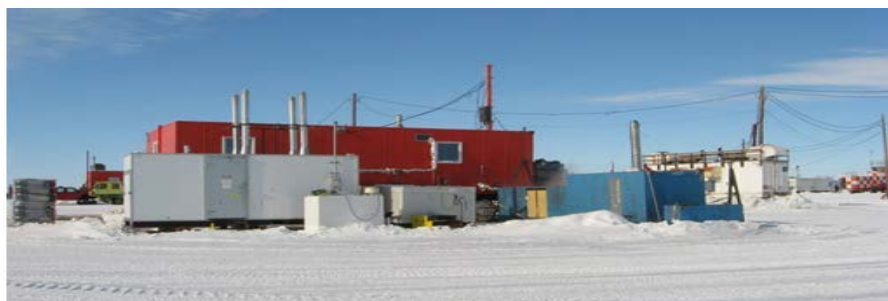
Figure 2. Incinerator and wastewater set up at Pegasus Runway, 2011–12.

The incinerator was first fielded at PEG during the 2010–11 season (Figure 2). After initial operation, we quickly identified several deficiencies with the system, as discussed in Section 2, and deemed the unit as not performing to specifications. We returned the unit to the manufacturer for revision and tested the updated incinerator unit during the 2011–12 season.

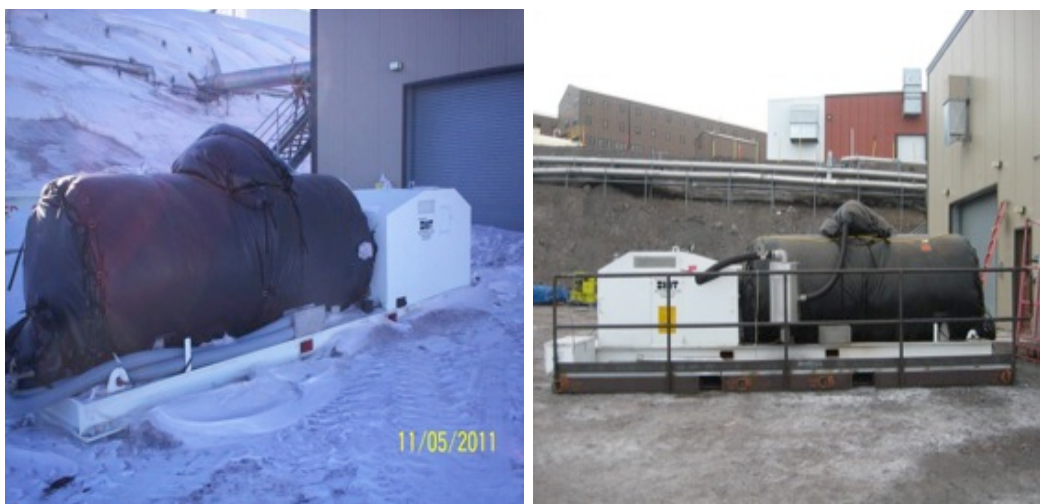
Figure 3. The vacuum tank as delivered (left) and after modification (right).

The vac tank that arrived at McMurdo during the 2011–12 season had to be modified immediately after arrival to ensure the safety of personnel and to limit snow drifting into the engine compartment. Modifications to the system included the addition of a platform with guardrails (as shown in Figure 3) because the Delta transporting it would put the unit approximately 6 ft off of the ground; the railing helped to prevent personnel from falling off of the Delta bed while operating the vac tank. Figure 4 shows the vac tank installed on the back of the Delta.

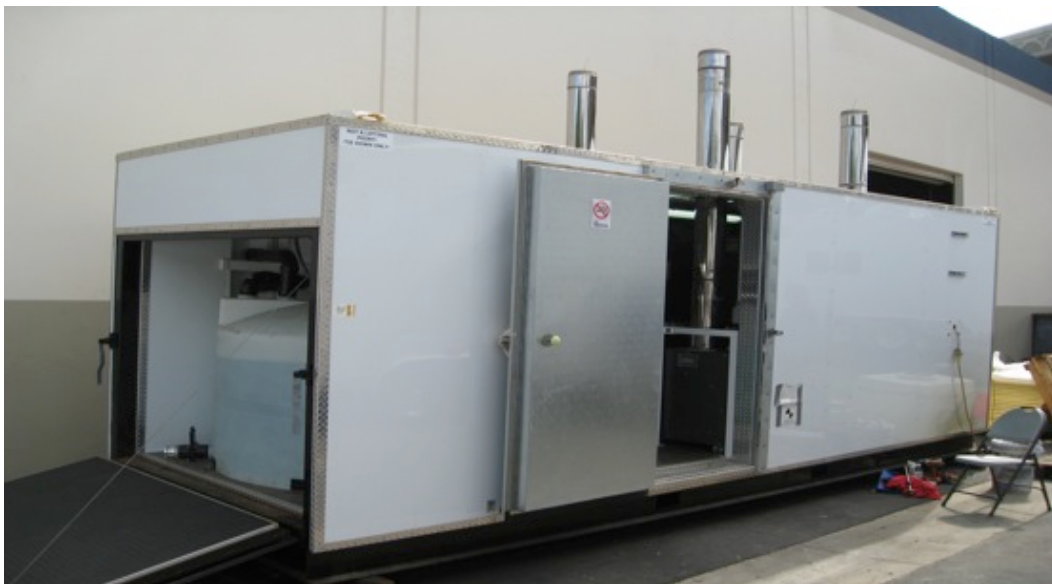
Figure 6. Incinerator at the manufacturer's facility, California.

The incinerator unit (Figure 6) first arrived at McMurdo station during the 2010–11 season. During the four weeks of testing performed by the contractor and vendor, CRREL noted multiple issues:

1. The burner overheated, causing the burners to shut off mid-cycle.
2. The tray overfilling, caused by double drawing of waste from the pumps and overfilling of the burning trays (Figure 7), resulted in black water saturating the burn chambers and spilling out onto the floor
3. Control panel wiring was different for each of the four burners, making it difficult to trouble shoot.
4. The tray life was less than manufacturer expectations of 300 hr. The actual life span was measured at approximately 75 hr each.
5. The space heater had problems operating.
6. The fork lift pockets were not installed.

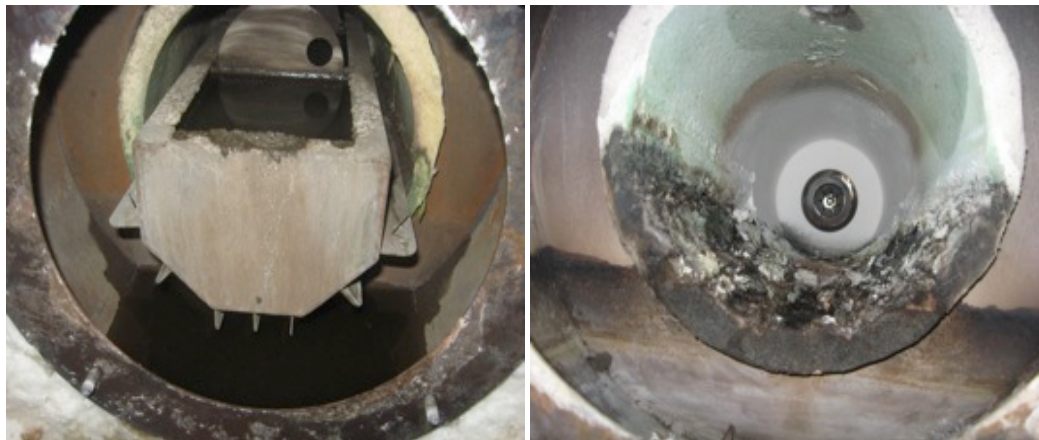
Figure 7. Tray overfilled, causing effluent to spill out of the tray (left) into the exhaust plenum and to leak out of the burner unit onto the floor, saturating the combustion chamber insulation with black water (right).

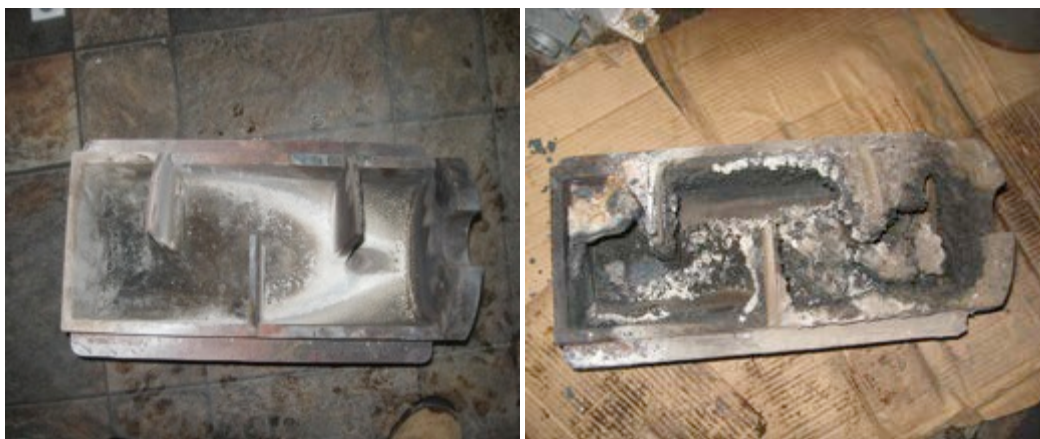
The new burner trays made of cast iron proved to be more reliable and longer lasting than the aluminum ones used the season before. However, an issue that was not visible during testing in California was the increased caking on the trays as shown in Figure 10. This led to increased tray maintenance to remove the buildup but did not affect the tray's life expectancy. We noted that the caking was reduced somewhat by increasing the burn temperatures in the combustion chamber. However, extended service at these higher temperatures is expected to reduce the tray life.

Figure 10. Cast iron tray before installation at McMurdo (left) and after normal usage during the 2011–12 season (right); note the visible caking on the tray on the right.

Furthermore, the burn trays were originally aluminum; but during the 2010–11 tests, we concluded that the trays did not hold up well to the hotter flame produced by AN-8 combustion (compared to that of propane), leading to premature failure of the aluminum trays. We replaced the aluminum trays with cast iron trays that had additional fins added to the design to create a more even heat distribution on the tray. These trays were reversible, which improved the life as well. These new trays were included as part of the upgrades, also.

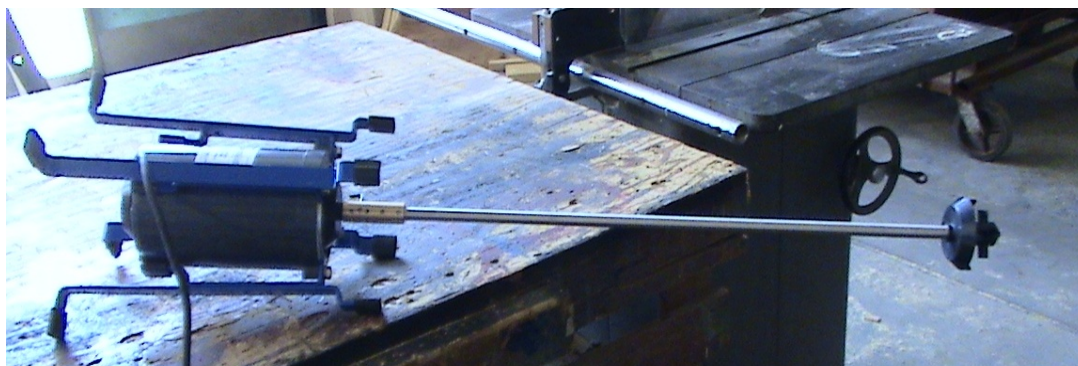
Figure 11. Incinerator holding tank aerator.

1. De-winterize and prepare the incinerator to operate with AN-8 fuel.
2. Install turbulence aerator with pre-fabricated mounting piece. (2 × 6s).
3. Run multiple cycles in the initial testing and confirm the proper operation of the incinerator based on the prior year's performance with the addition of the aerator for the 2012 season.

Results documented in *Global Inventive Industries 720S Incinerator* (Bragg 2013) by Antarctic Support Contract personnel stated that the implementation of the aeration system (Figure 11) resulted in a less metallic smell. Changing the fuel type did not affect the smell; however, the burners were not adjusted for the fuel type, creating a light brown smoke from the stacks when burning diesel vs. a white smoke from the AN-8. Diluting the waste stream did not have an effect on the smell. It should be noted that because of the lack of non-objective “smelling” techniques, it was up to the operator’s discretion to determine the change in smell when the incinerator was operating.

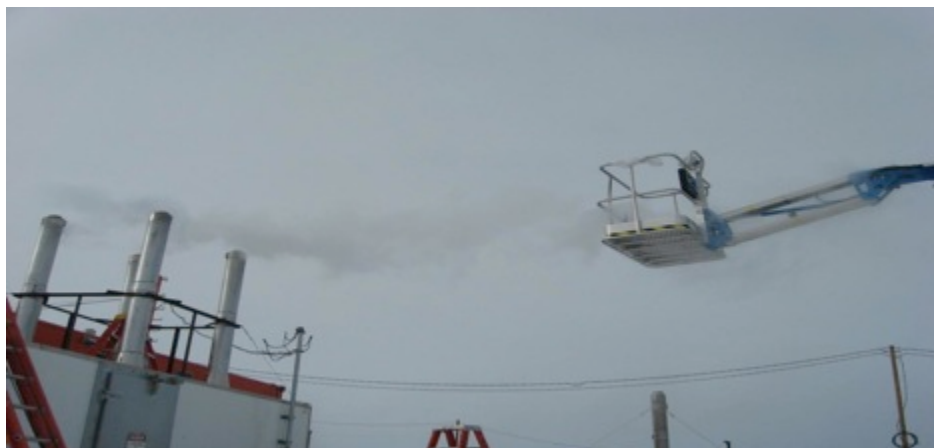
Figure 12. Emissions testing of the incinerator at Pegasus Airfield.

In an effort to understand the source of the odor and thereby possible methods to reduce it, we conducted emissions testing (Figure 12) both at the factory and in the field. Appendix A provides a summary of those test results. Based on these findings it appears that sulfur dioxide could be the main source of the odor as it was the only compound detected that was above its odor threshold. Unfortunately, because of testing services available, the test methods used did not detect all possible compounds. For example, hydrogen sulfide—which produces a “rotten egg” smell—was not tested for, and that may also have been a contributor to the odor. Fortunately, both of these compounds can be removed from the flue gases using scrubber technology. We recommend that future tests of the incinerator

employ stack scrubbers to determine the viability of using that technology to reduce the odor associated with incinerator emissions.

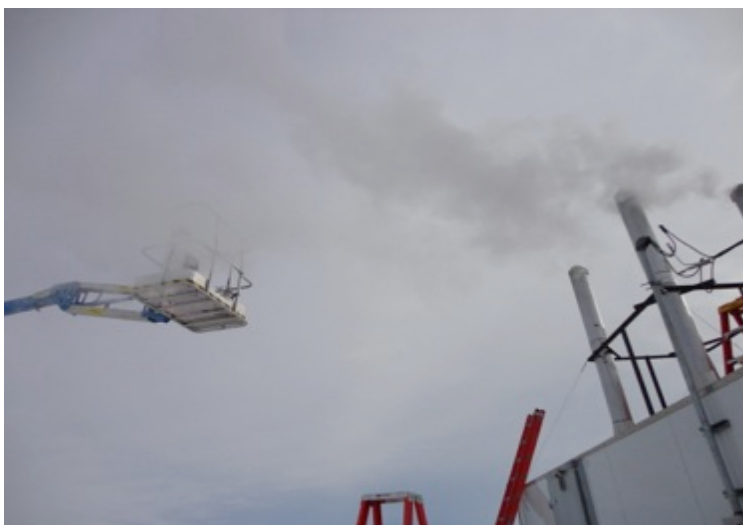
Figure A2. On 14 February 2012, the sampler was placed in the basket of the lift truck and positioned in the exhaust plume as shown.

Two of these three samples (one from the 11 February sampling and the sole sampling on 14 February) were sent to Hill Labs in New Zealand to determine the VOCs contained in the emissions. Table A3 lists the only compounds found in the emissions that were above the detection limits of the analyzing equipment used by Hill Labs. It is interesting to note that contrary to expectations, the measured concentrations of the detected VOCs are quite comparable even though the sampling locations were different and though one would expect concentrations from the sample taken on 11 February to be much lower.
